# ProcessSCAN<sup>TM</sup>

*Infrared Thermographic Services*

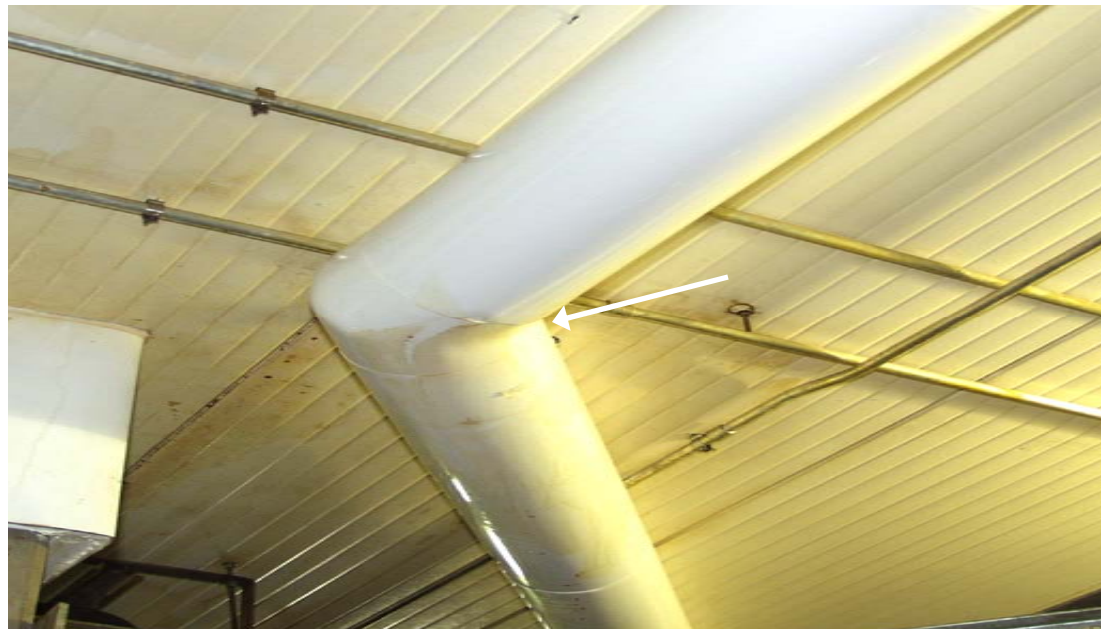
**Leak  
in Drain  
Lines**

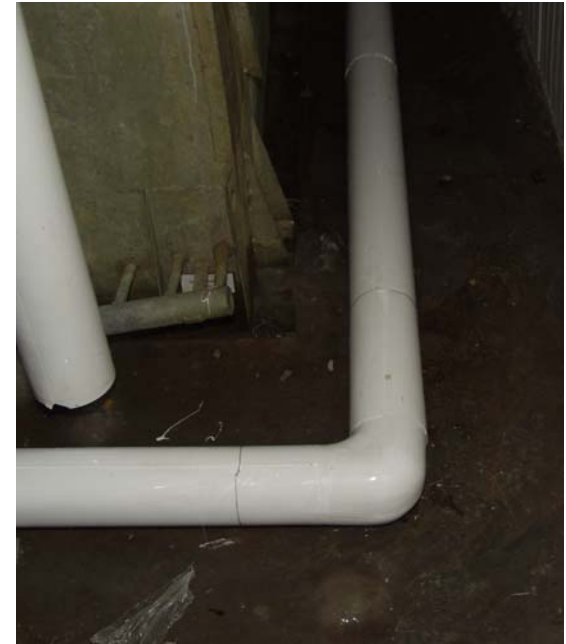
**Heat Trace  
in  
Condensate  
Lines**

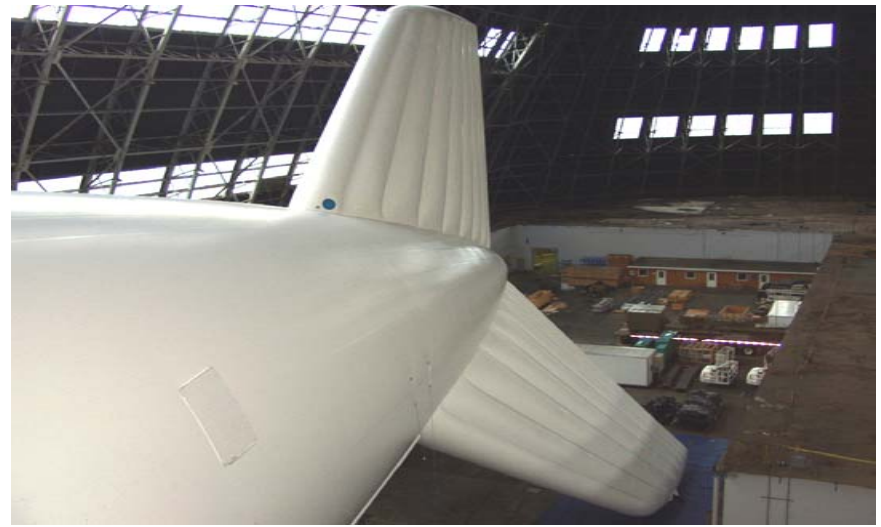
# Aerostat Helium Leakage Detection using Infrared Thermography

ProcessSCAN's technique relies on detecting very small temperature differences to see the escape of helium (or other gases). The gas itself is not visible, but the cooling effect of escaping gas impinging on the surface is detected. We methodically go down the surfaces quickly and close enough to see the small, cooler areas.

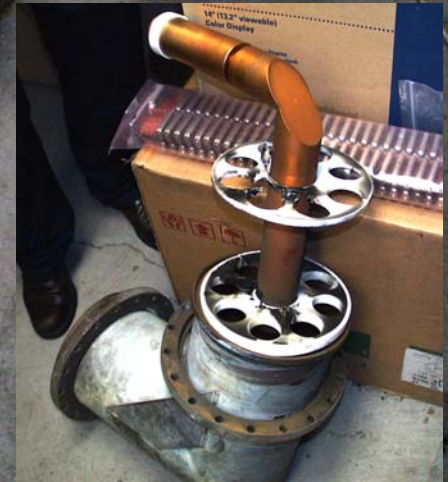
**Damage to  
Elbow  
Complex  
found on  
IR Survey**

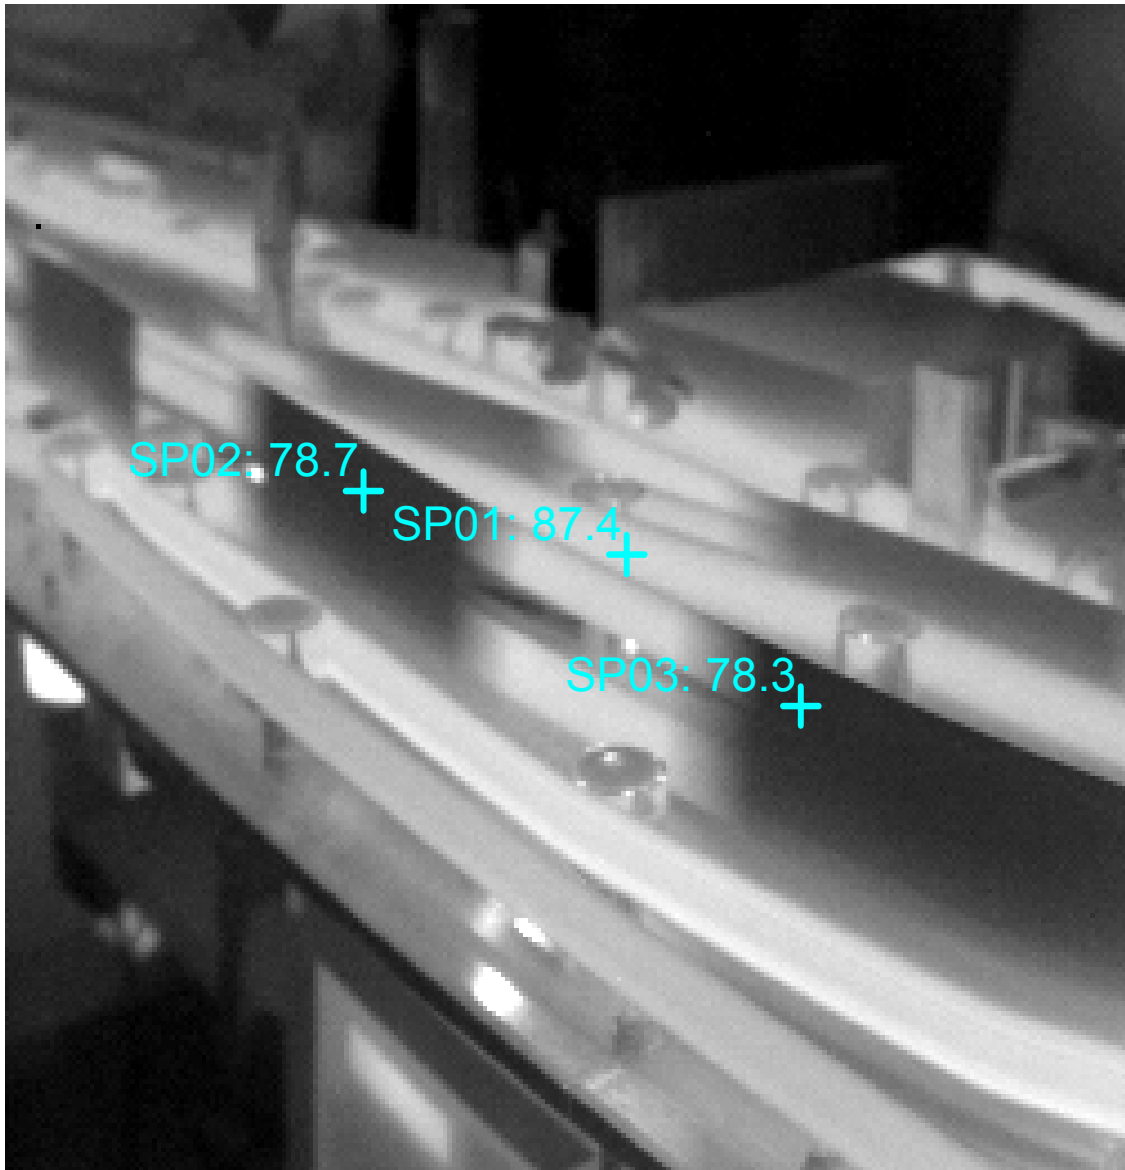
# Bar Code Sorters

The mail is ~10F degrees cooler.  
This has a cooling effect on the belts/bearings, etc.

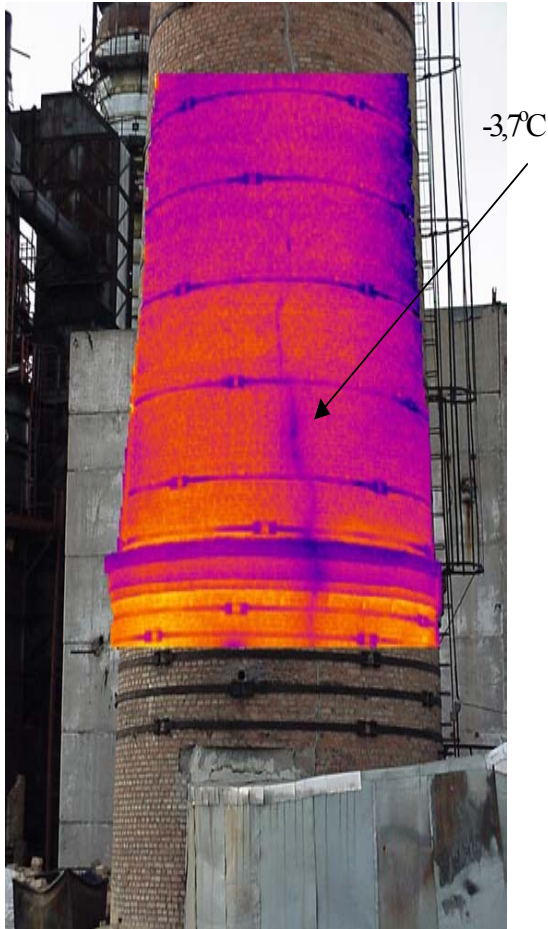
**A low quality repair  
of a through-crack**

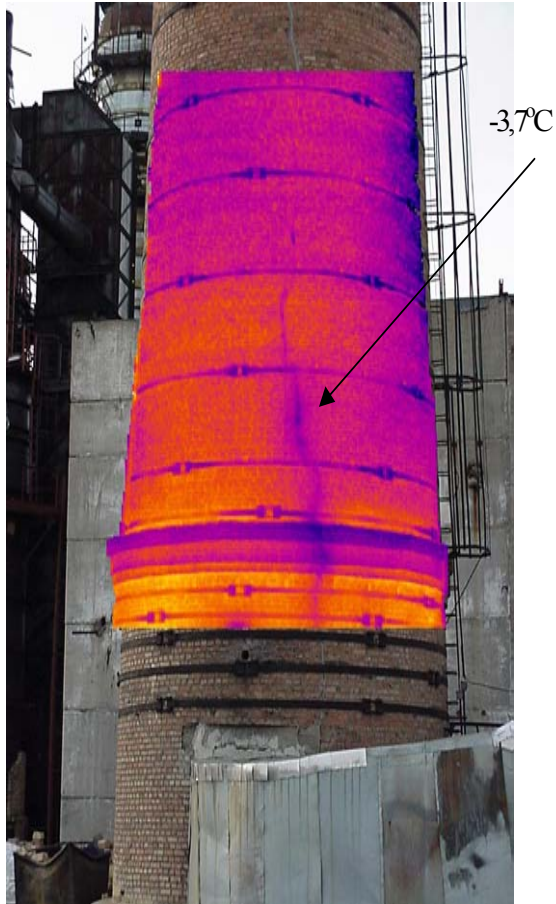
**A low quality of a  
through-crack repair**
